ANALYSIS OF THE CAUSE OF TRIBOLOGICAL DAMAGE TO VALVE ROCKERS IN A DIESEL ENGINE

Grzegorz Sikora

Gdynia Maritime University, Morska 81-87, 81-225 Gdynia, Poland,

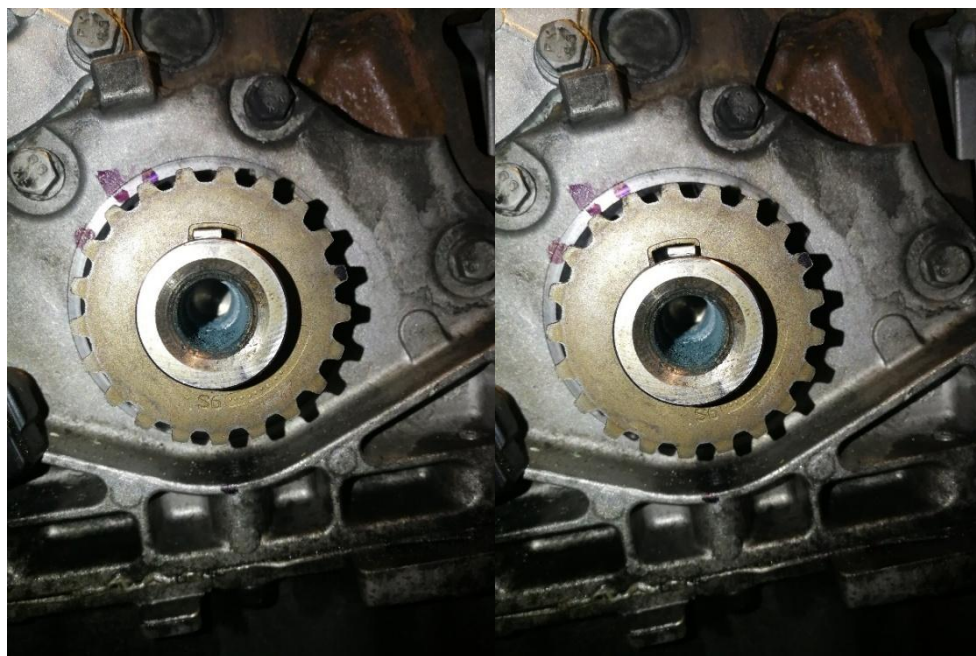
The angle of possible timing misalignment due to the floating key was calculated using CAD software based on the measured dimensions. Figure 1 illustrates the extreme positions of the timing gear on the crankshaft, while Figure 2 presents a geometric representation of these relationships. The correct positioning of the timing gear relative to the crankshaft is achieved by centrally aligning the key within the machined slot of the gear. The gear can rotate by 10.86° to the right, advancing the timing relative to the crankshaft, or by the same amount to the left, delaying the timing. However, considering the correct reference position, the actual misalignment would be half of this value: 5.43° in either direction.

Fig. 1. Extreme positions of the sprocket on the crankshaft.
On the left side, the timing is advanced relative to the crankshaft.
On the right side, the timing is retarded relative to the crankshaft

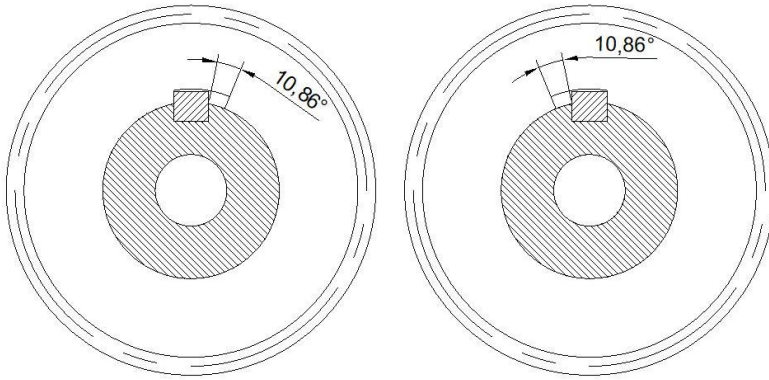
Since the camshaft rotates at half the speed of the crankshaft [Wajand and Wajand 1993; Witkowski 2017] a 5.43° misalignment of the crankshaft gear results in a 2.715° shift of the camshafts. In this case, the misalignment of the timing gear relative to the crankshaft could have been caused by the reuse of the old crankshaft pulley bolt, insufficient tightening of this bolt, or crankshaft rotation due to the absence of proper flywheel locking during the timing belt replacement.

Fig. 2. Graphical representation of the sprocket displacement relative to the crankshaft

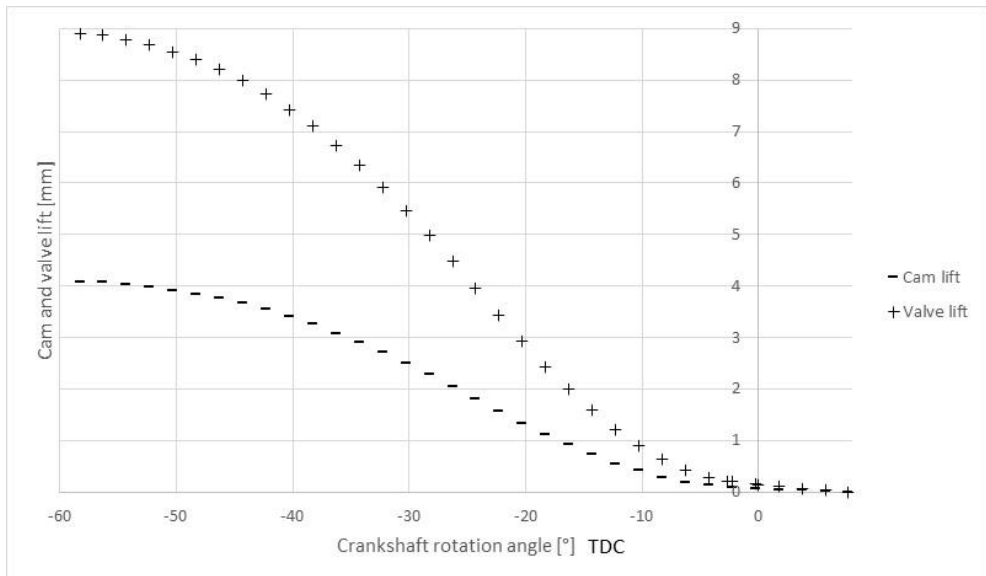
To assess the impact of timing phase adjustment on the exhaust valve lift, the exhaust cam profile was measured and referenced against the delayed valve closing angle, taking into account the rocker arm ratio. Figure 3 shows the measured cam profile from the maximum lift point to the end of the profile.

The calculated exhaust valve opening height at the moment the piston passes through top dead center (TDC) is 0.143 mm. When the timing system is retarded by 2.715° relative to the crankshaft, this height increases to 0.214 mm. The difference between these two values is 0.071 mm, which is 0.015 mm more than the specified

Fig. 3. Cam lift and valve opening height as a function of camshaft rotation

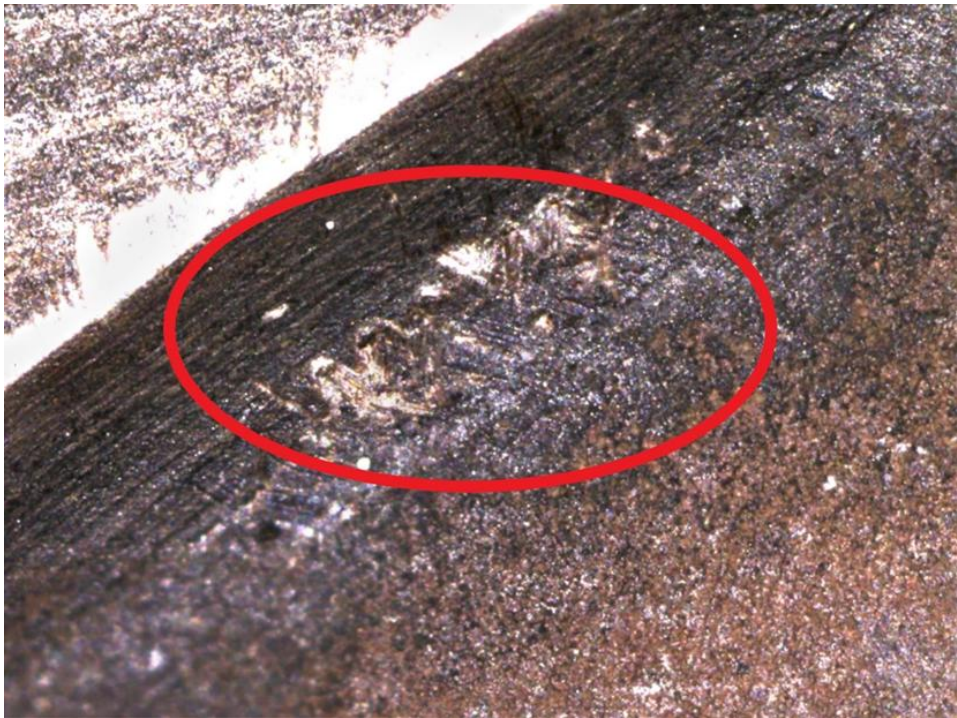
Figure 4 highlights a mark located in the milled section of the piston situated beneath the exhaust valves.

Fig. 4. Traces of piston–exhaust valve contact

The traces marked in Figure 4 could only have formed as a result of contact between the piston and an exhaust valve. The observed defect is located on the wall of the milled recess beneath the exhaust valves, and its height indicates that the valve–piston collision occurred within that range.

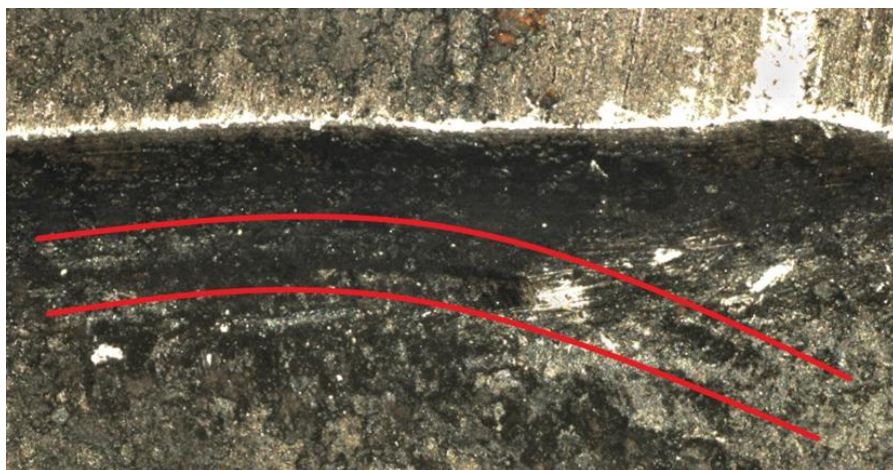
In other areas of the piston recess, numerous scratches and imprints were found, with arc diameters close to 25 mm. However, these marks are relatively short and faint, making their interpretation potentially subjective.

Fig. 5. Imprint from contact with the valve

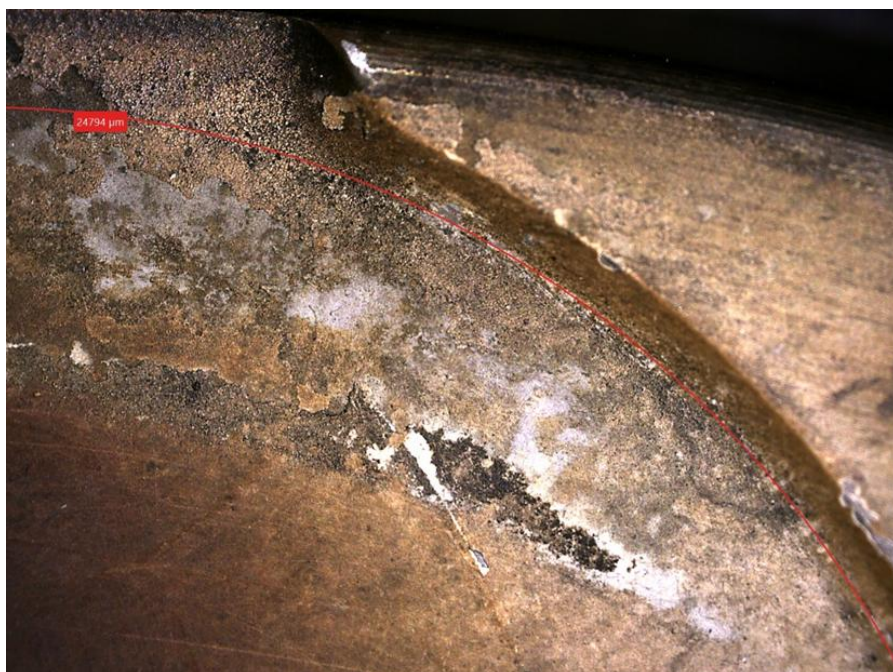
Figure 6 also shows a layer of scale formed as a result of fuel injection. This scale is disrupted in multiple areas, which may indicate contact between the piston and the valve. Detached fragments of the scale could have entered the engine oil, a possibility that was addressed in the trace element analysis of the oil.

Fig. 6. Imprints with a diameter close to that of the valve head

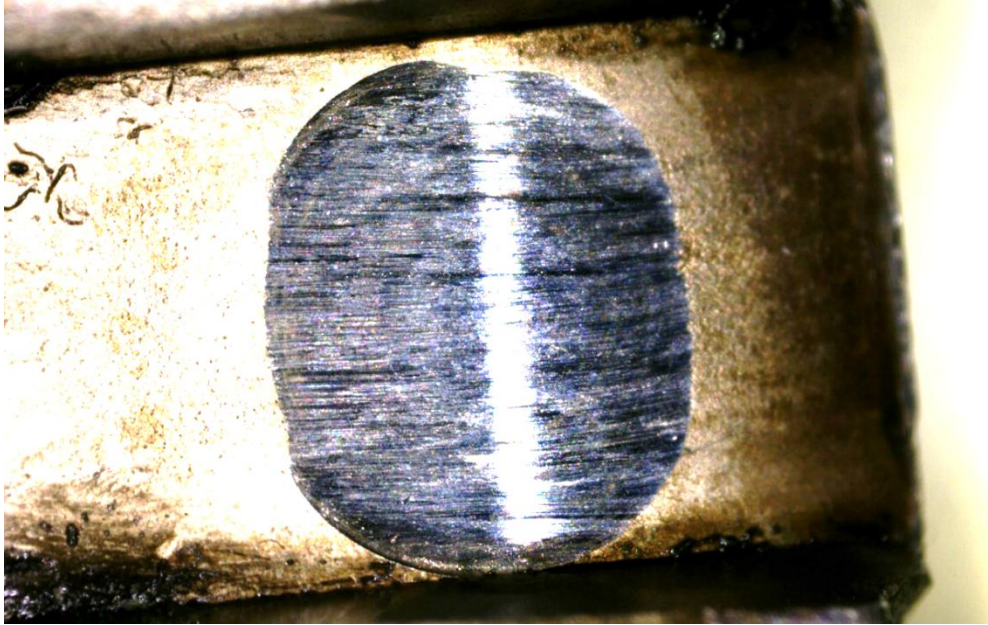
Figure 7 shows the area of proper contact between the rocker arm and the valve stem. This reference image pertains to an undamaged intake valve rocker arm.

Fig. 7. Normal wear on the valve rocker arm

The microscopic image shown in Figure 7 confirms proper interaction within the friction node and aligns with findings reported in the literature [Włodarski 2006; Kułakowska et al. 2018]. It displays longitudinal scratches oriented along the direction of valve stem movement. These marks are continuous and parallel throughout the entire contact area. The valve opening cycle begins with the stem positioned on the left side, and at maximum lift, the stem shifts towards the right side of the rocker arm wear area.

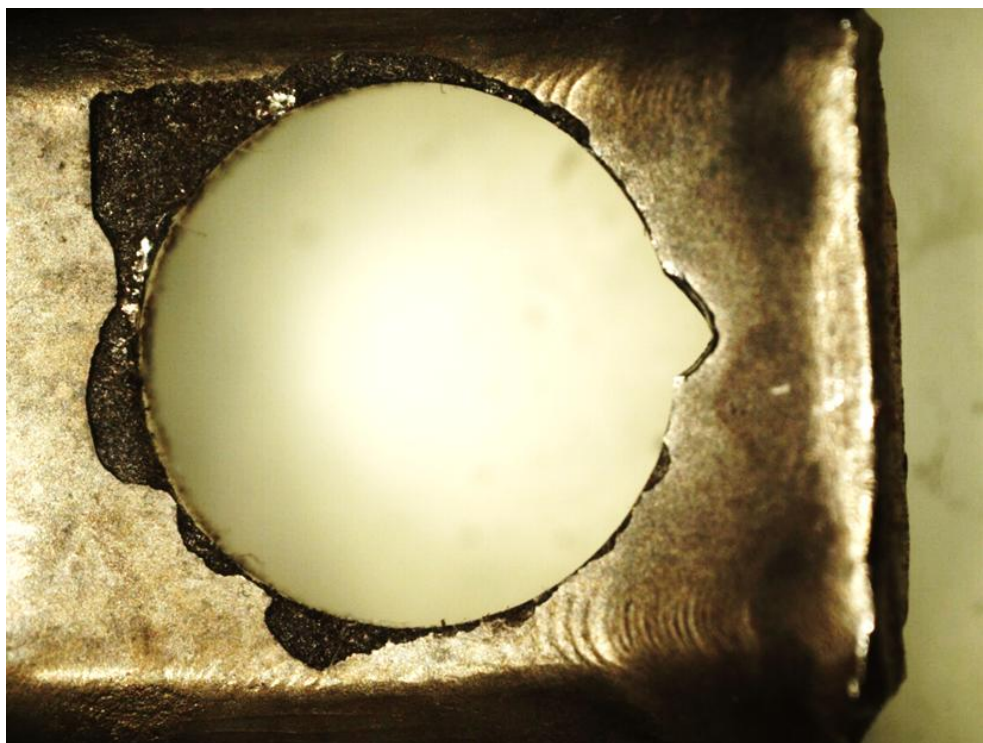
Microscopic analysis was also performed on the valve rocker arm that suffered perforation and led to the engine failure, see Figure 8.

In Figure 8, material chipping is visible on the left side, indicating that the perforation occurred either at the beginning of valve opening or during valve closing. This area experienced the greatest material weakening due to loss, which correlates with increased load in the friction node at the start of valve opening or the end of valve closing [Tuszyński 2012; Wierzcholski and Miszczak 2015].

Fig. 8. Perforated valve rocker arm

The increased load during valve opening is caused by the presence of exhaust gases in the cylinder. However, this is a gradual load that varies with the camshaft rotation angle and is not impact-based. In contrast, increased load in the friction node during valve closing can only result from a collision between the piston and the exhaust valve. This is an impact load, as the piston completes a full stroke of 88 mm within the same time frame, while the valve moves only about 9 mm.

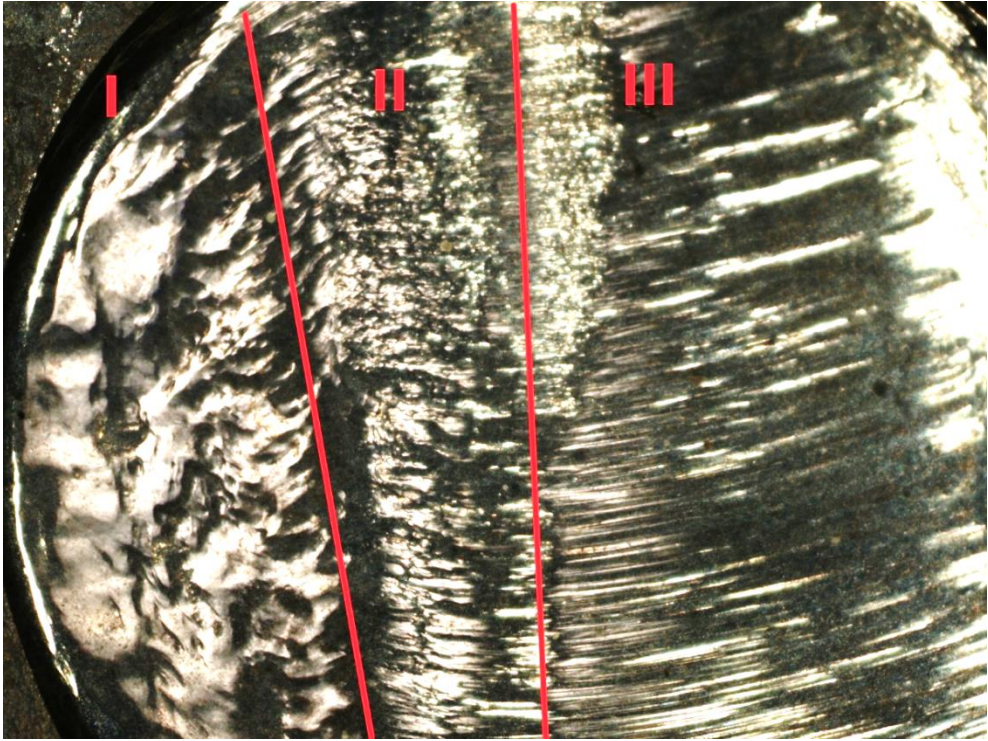
Figure 9 shows an exhaust valve rocker arm exhibiting signs of scuffing. Similar wear marks are present to varying degrees on all the rocker arms. This wear trace can be divided into three zones:

- Zone I: A scratch-free surface with varied height. The top layer is non-directional with rounded peaks, resembling plastic deformation typical of burnishing processes.
- Zone II: A swelling zone, where material from Zone I has been displaced. The increased volume in this zone is visible to the naked eye.
- Zone III: Deep, parallel scratches aligned with the direction of valve stem interaction. The depth of these scratches and the significant material loss in this zone are due to plastic deformation of the valve stem, which occurred as a result of the piston-exhaust valve collision.

Fig. 9. Microstructure of the scuffing zone on the rocker arm at $\times 74$ magnification

The differences observed between zones I, II, and III ultimately indicate that the cause of tribological damage to the valve rocker arms was impact-induced overload within the friction node, resulting from collisions between the piston and the valves. If the overload had occurred during valve opening and was related to exhaust gas pressure, material loss could also be expected. However, in such a case, the wear pattern at the valve stem-rocker arm interface would resemble that of the intake valves, as shown in Figure 7.
